# Characteristics of Railway-Roadway Level Crossings at Coastal Railway Line in Sri Lanka

**Abstract**— Rail transportation is a safe, efficient, continuously operating sustainable transportation mode, in all-weather conditions, and light conditions. Along with these advantages, the role of rail transport has become increasingly important. Therefore, it is important to investigate the characteristics of the railway-roadway level crossings in Sri Lanka. Railway-roadway level crossings at coastal railway line from Aluthgama to Ambalangoda were visited to collect the roadway, railway, traffic, environmental, and crash data. Out of 51 crossings that observed in this study, about 94.1% of railway-roadway level crossings were facilitated with active safety measures. About 7.0% of railway-roadway level crossings were without gates and among them 33.3% of crossings were facilitated with passive safety measures and other crossings were under unsafe conditions. Several problems related to railway-roadway level crossing were identified. The collected data could be utilized to develop various statistical models for identifying relationships between the number of crashes and level crossing cha

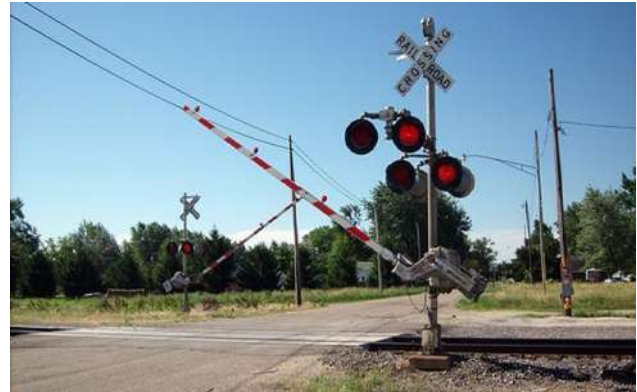
Figure 1. A Railway-roadway Level Crossing
